**2008 Operations, Maintenance,  
and Monitoring Report**

**Black Bayou Hydrologic Restoration**

State Project Number CS-27  
Priority Project List 6

April 2009  
Calcasieu and Cameron Parishes

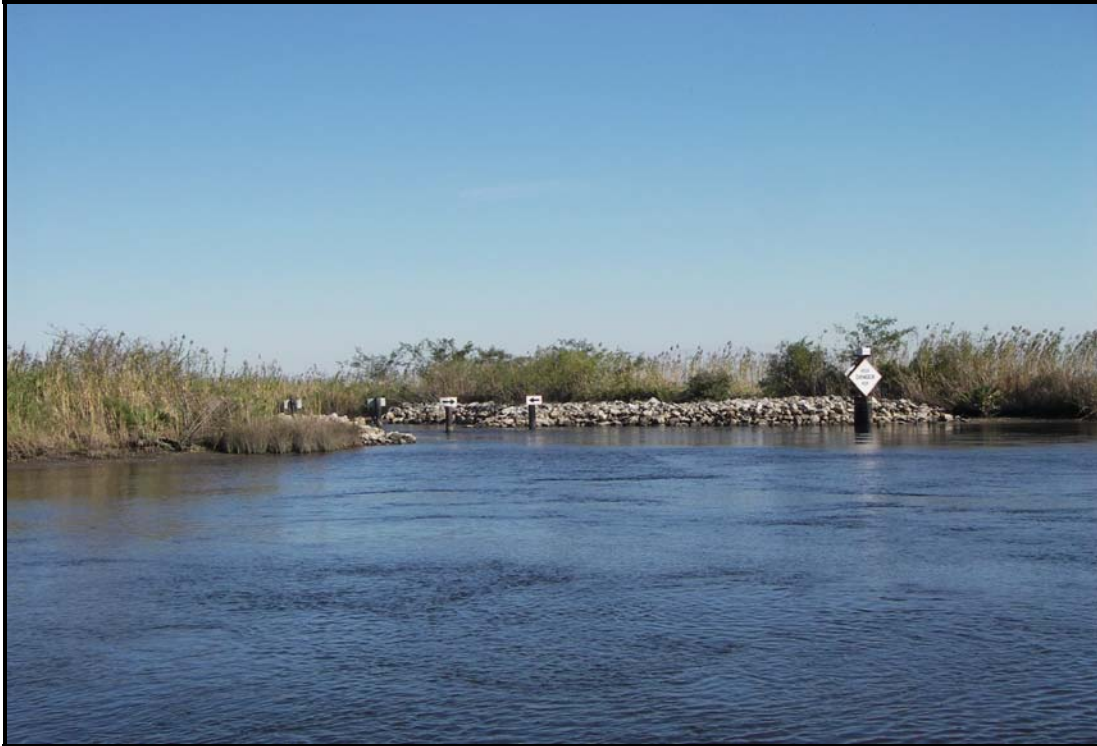
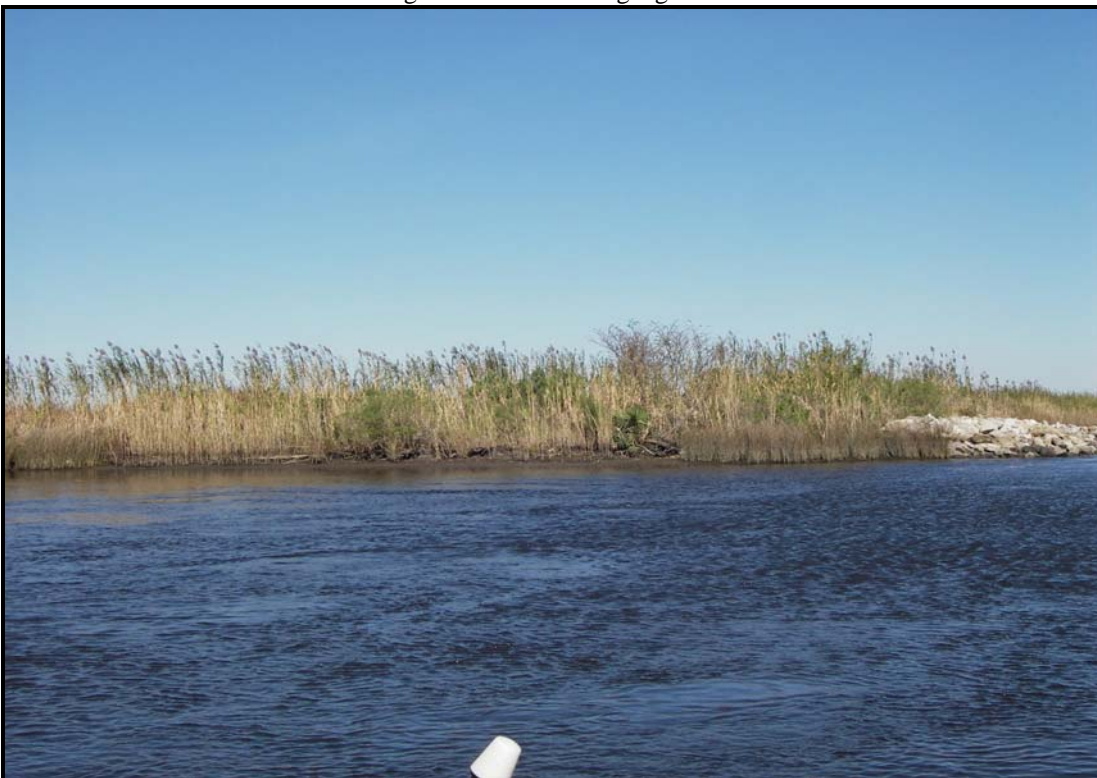
The rock weir is in excellent condition. Signage is stable. The erosion on the SE bank, while has not gotten any worse, will continue to be monitored. No immediate need for maintenance at this structure. Conditions of the Navigational Aid Lights were last inspected in November '07. (Photos: Appendix B, Photos 1-3)

**Photo 1**—Navigational Aids and signage at Block's Creek

**Photo 2**—western side of Block's Creek Structure & signage

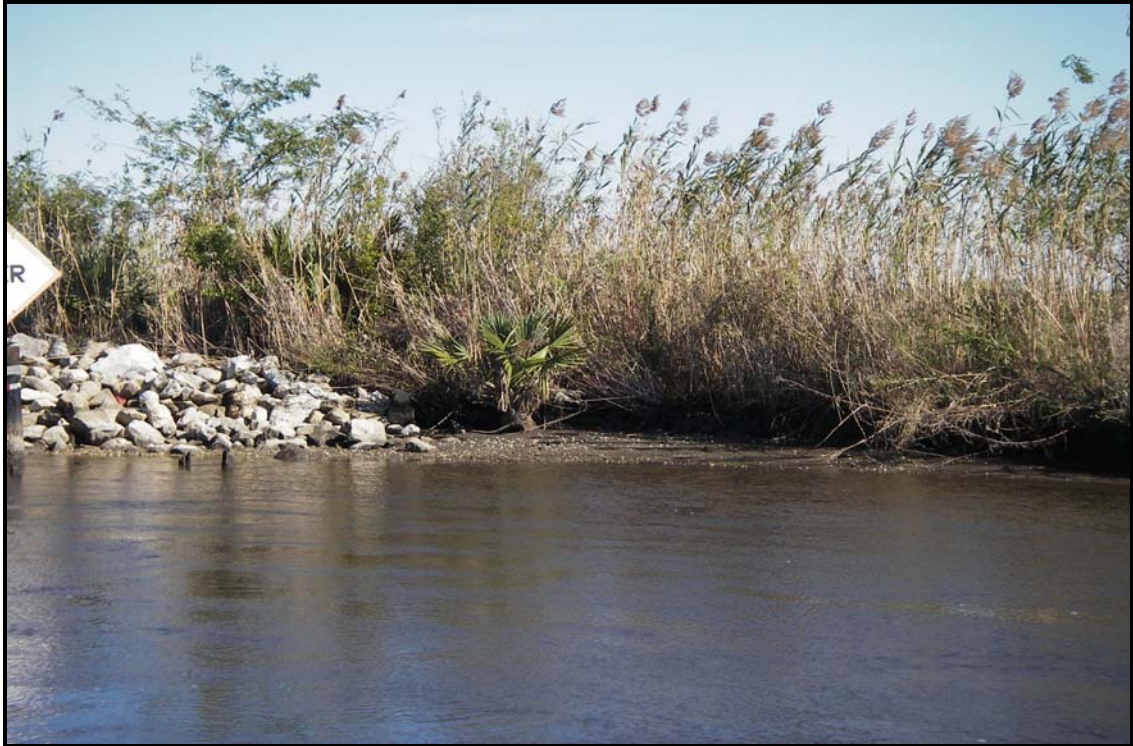
**Photo 3**—erosion on SE end of Block's Creek Structure

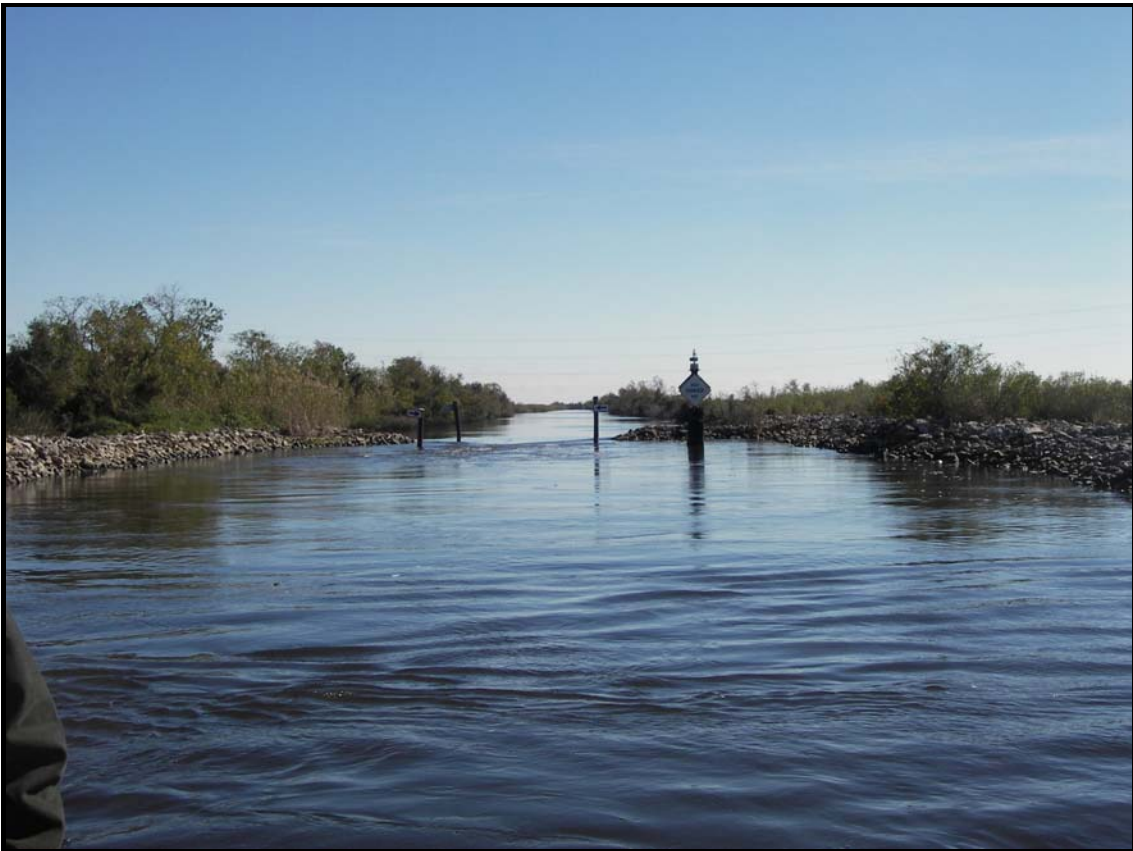
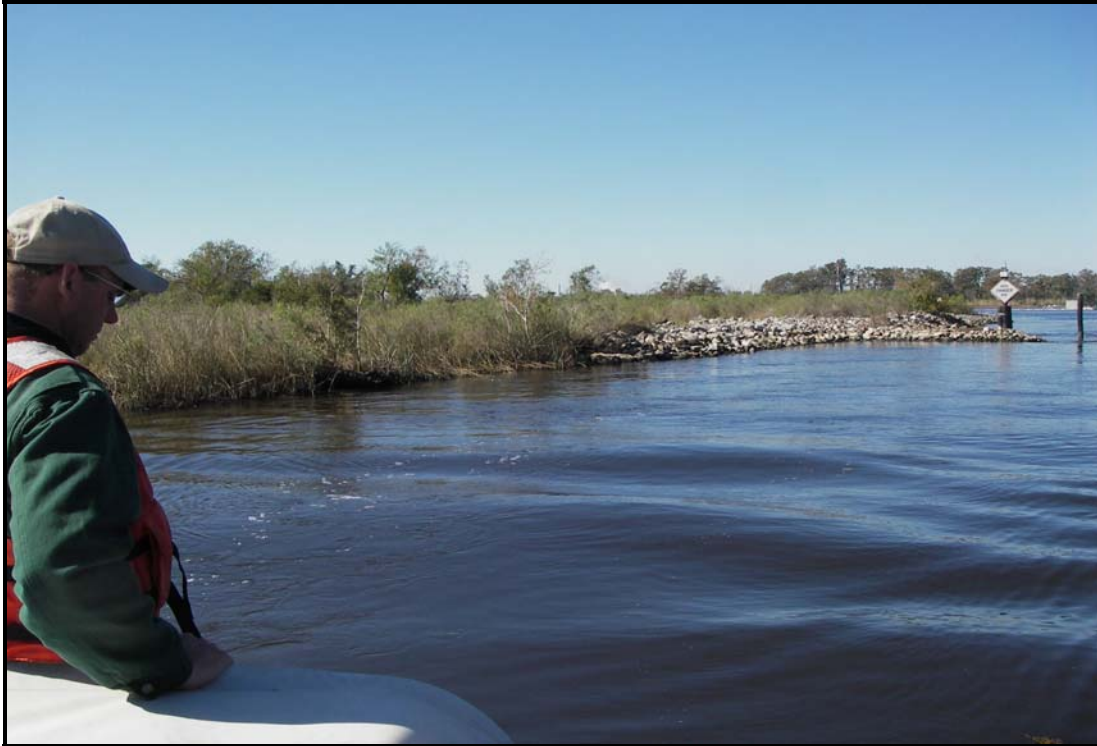
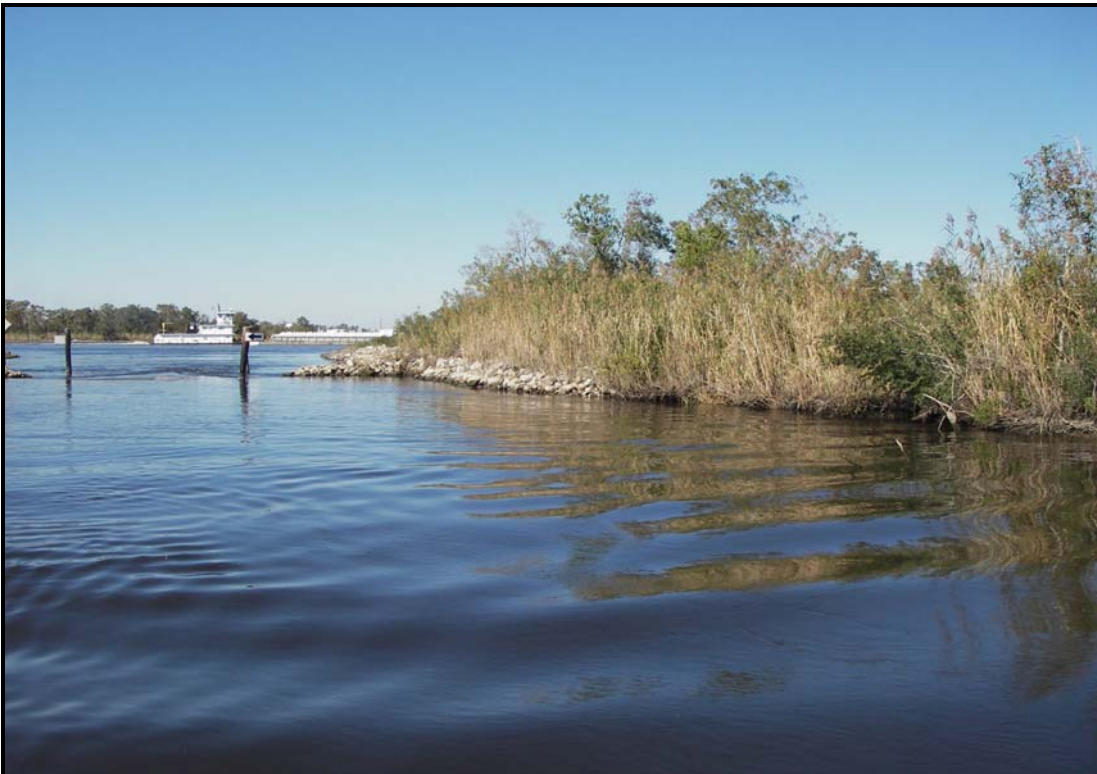
The weir is in good condition. There is some minor scouring along the canal banks inside of the weir at the end of the dike that will continue to be monitored. Severe current through the weir has caused problems for boaters in the area. The SE arrow sign is missing. As part of the maintenance project scheduled for the fall of 2008, the remaining piling will be removed and warning signs similar to the ones on the Black Bayou Cut-Off canal will be used. The Navigational Aid Lights were last inspected in November '07. (Photos: Appendix B, Photos 4-6)

**Photo 4**—Burton Canal Structure

**Photo 5**—SE rock at Burton Canal Structure

**Photo 6**—NE rock on Burton Canal Structure

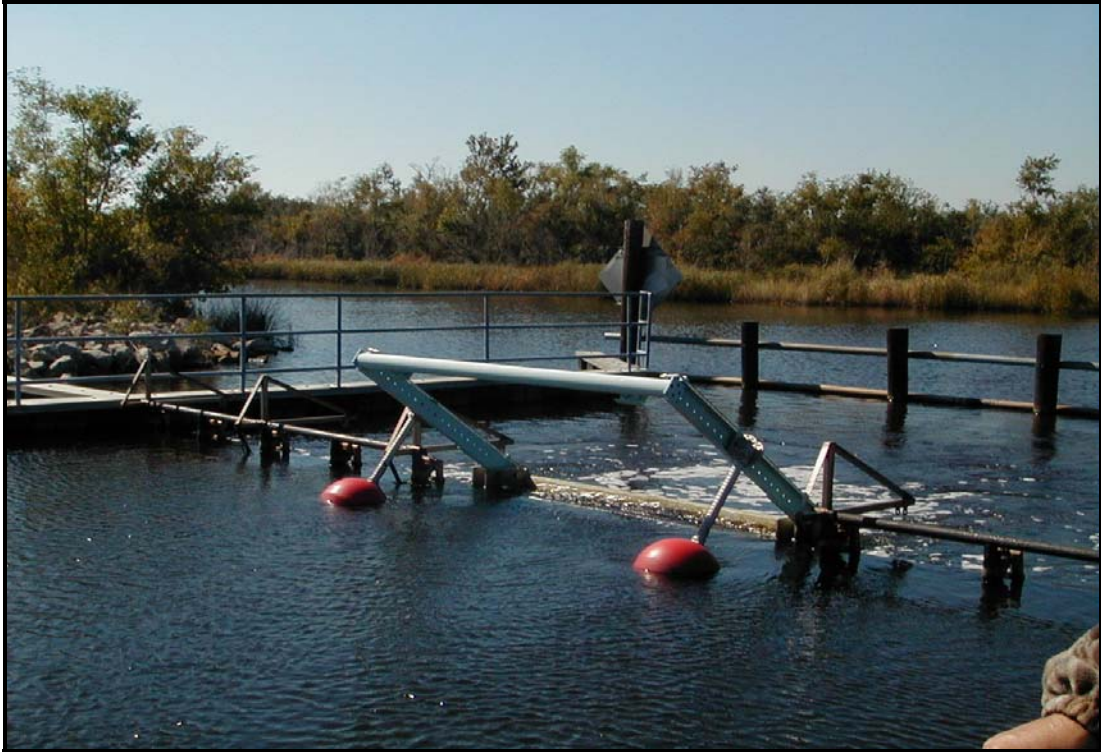
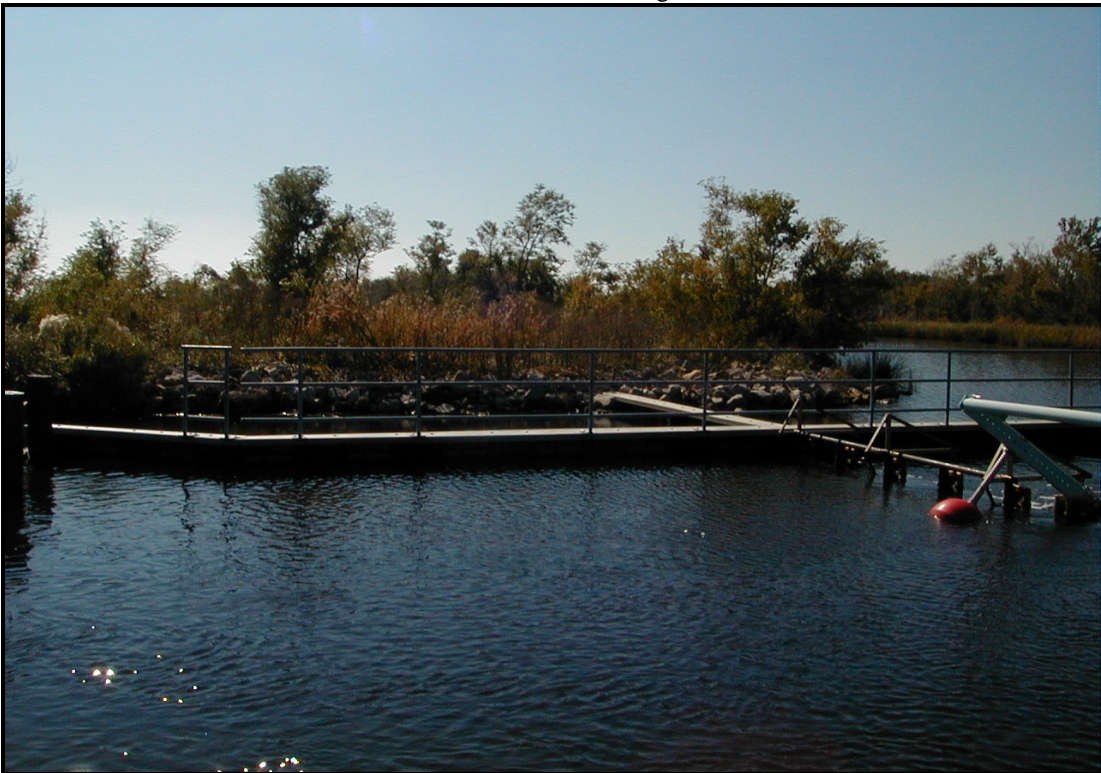
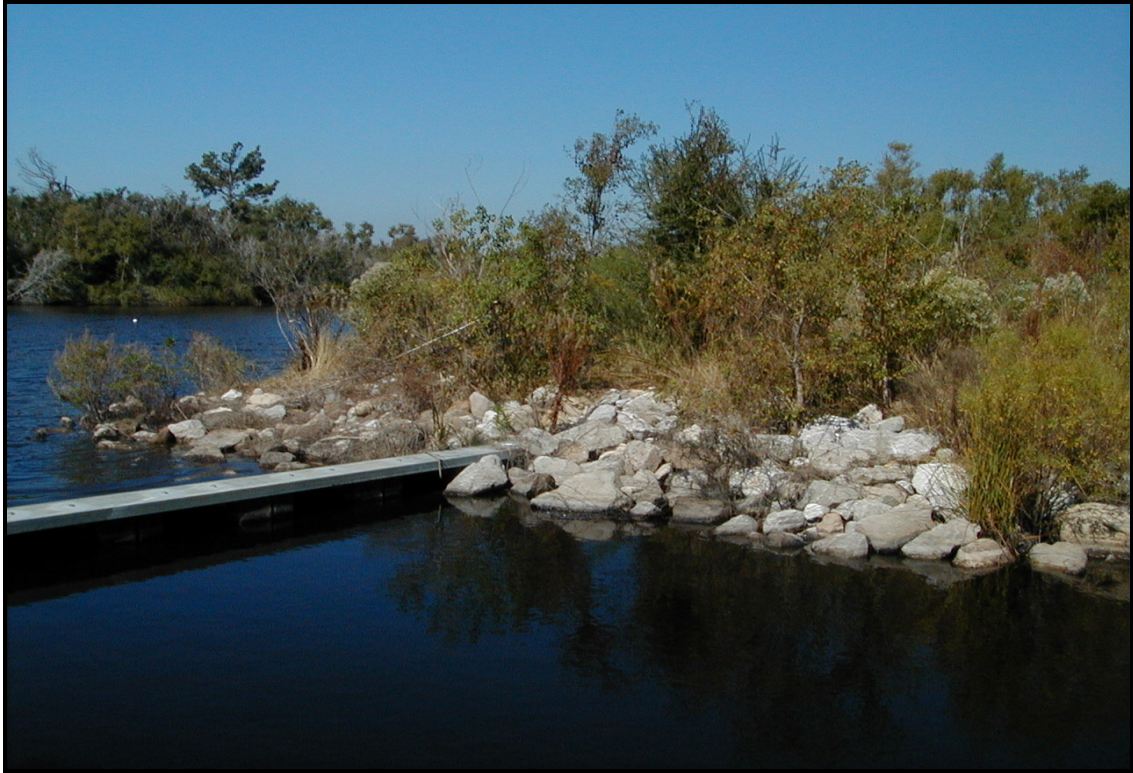
The structure itself is in very good condition. Signage, railings, wingwalls, etc. are in as-built condition. Pillow blocks on new flap have rusted to the point that the flapgate has frozen and cannot move. The entire hinge mechanism will be replaced in the maintenance event which is scheduled for the fall of 2008. (Photos: Appendix B, Photos 7-10)

**Photo 7—SRT Gate railings, etc.**

**Photo 8—SRT Gate S end**

**Photo 9**—SRT Gate N end

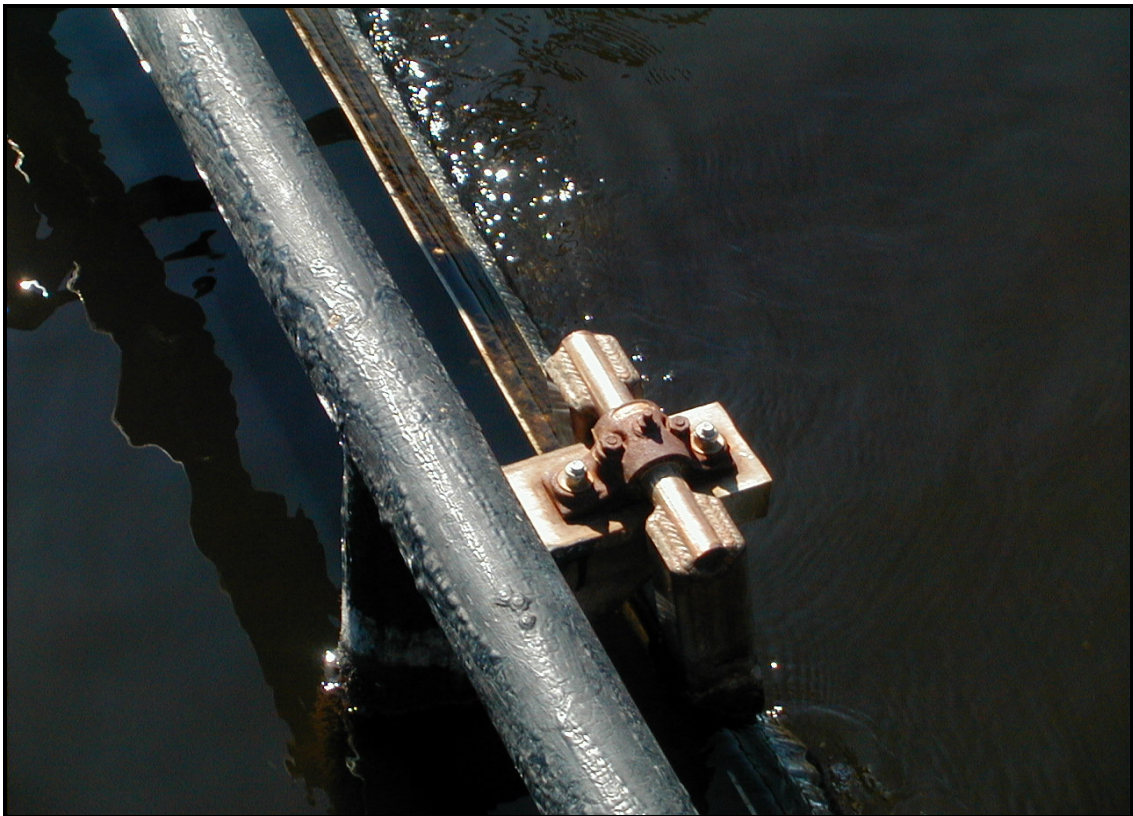
**Photo 10**—SRT Gate pillow block on new flap

Repair flap gate hinge connections at the SRT gate, plug gaps on the spoil banks behind the GIWW rock dike, signage along Burton Canal, and cap rock plug at SRT gate.

- Add bags of concrete to raise the elevation of the rock plug
- Install a new warning sign at Burton Canal
- Address low elevations and gaps in GIWW rock dike and canal closures with concrete bags
- Install staff gauges
- Repair the frozen flap on the SRT Gate.

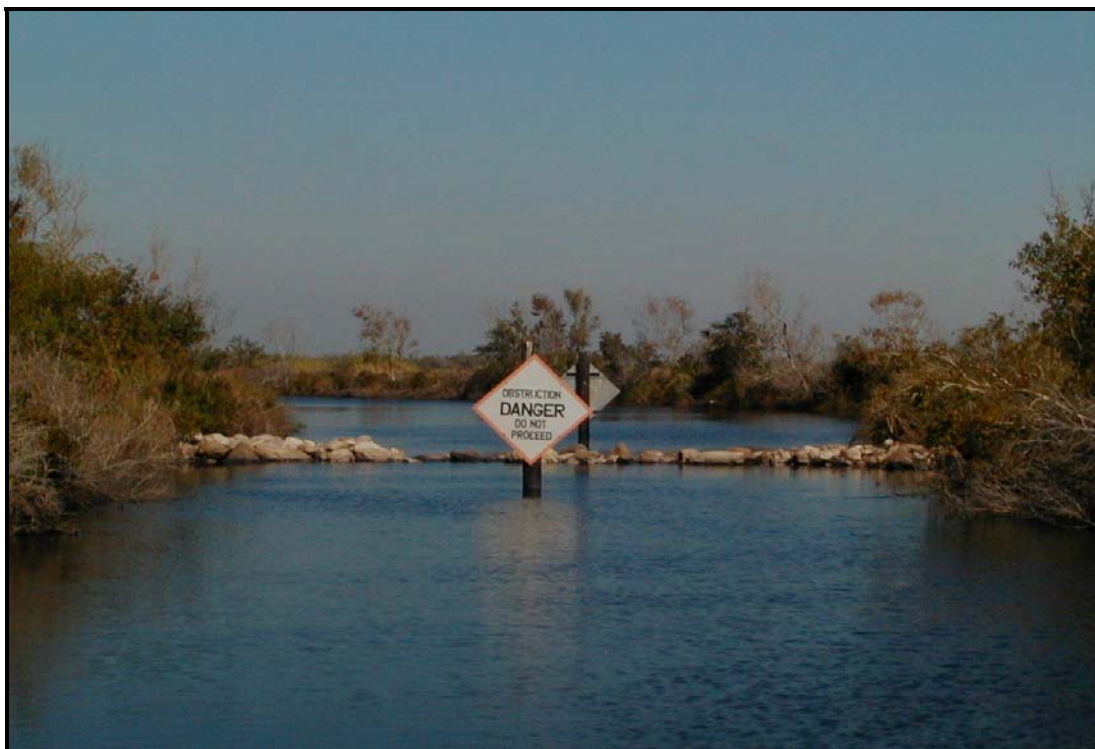
Rock has either been moved or has settled slightly to an approximate elevation of +2.5 feet NAVD '88 in spots. Also, eastern end of the dike is well below elevation where it ties into the bank. This will be addressed, with sacks of QuickCrete placed on the crown of the plug and on the tie-in to the bank, in the maintenance event scheduled for the fall of 2008. (Photos: Appendix B, Photo 11)

**Photo 11**—Rock plug near SRT Gate

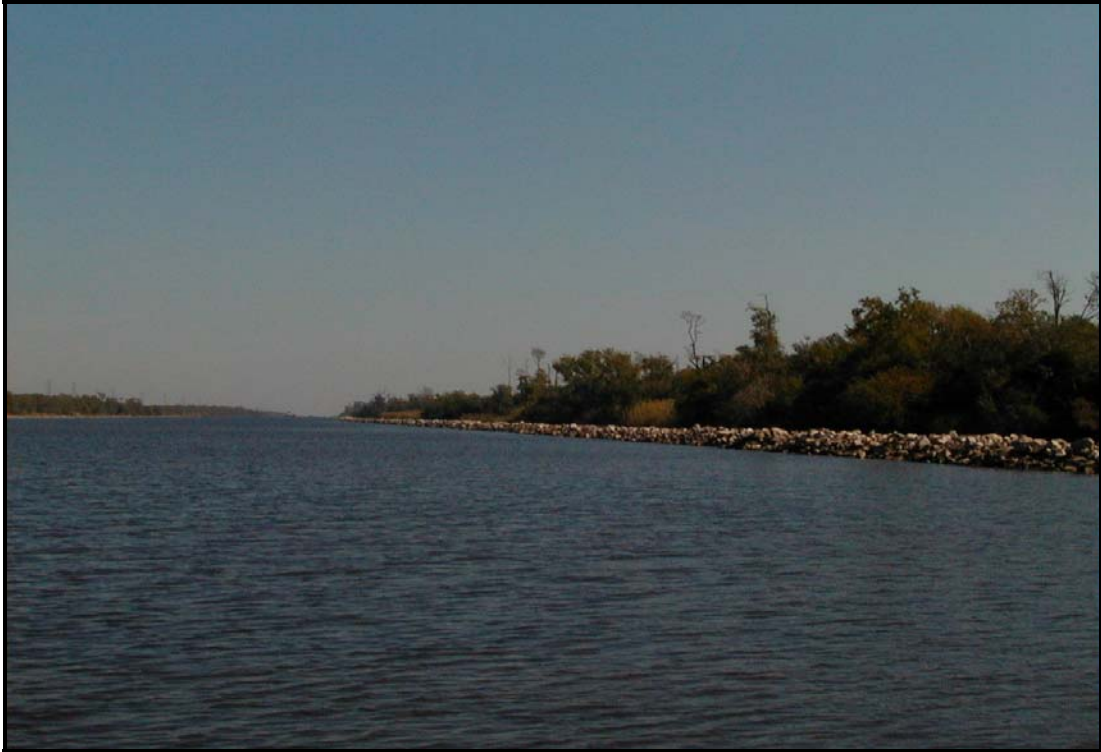
Tie-ins on both the east and west end of the dike are stable. Several random spots along the dike were checked and no apparent toe scour is occurring. As mentioned in previous inspections, the warning signs at both the Vinton and Black Bayou closures have been stolen. The spoil placed behind the rock dike at the Black Bayou Canal has washed away on the western end. Spoil is also gone on the eastern end of the closure at Vinton Canal. There is also a gap in the rock at this location. The second gap from the east has a large gap on the eastern end of the C-stone closure. Rapid water exchange is occurring here and the breach is getting wider and deeper than in previous inspections. The alligator crossing, mentioned in previous inspections, on the 3<sup>rd</sup> closure from the east has not gotten any worse. These three areas will be addressed with QuickCrete sacks in the maintenance event in the fall of 2008. (Photos: Appendix B, Photos 13-17)

**Photo 13**—Typical section of rock dike

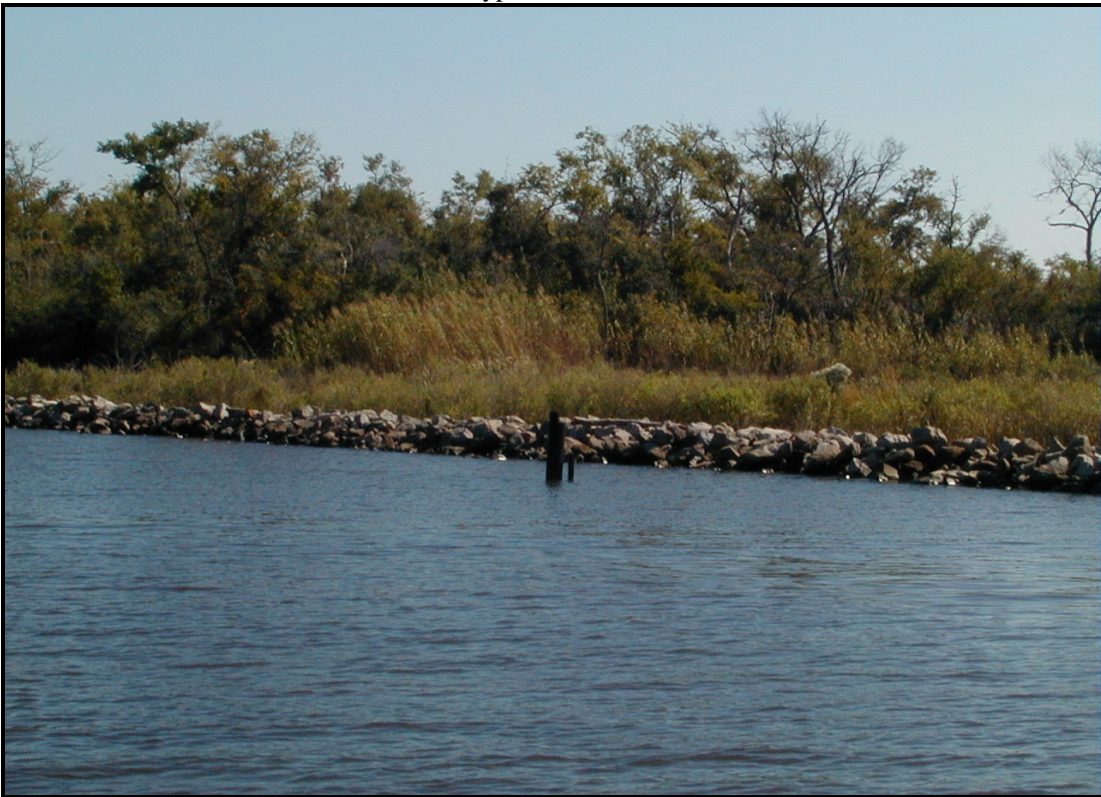
**Photo 14**—Missing sign at Black Bayou

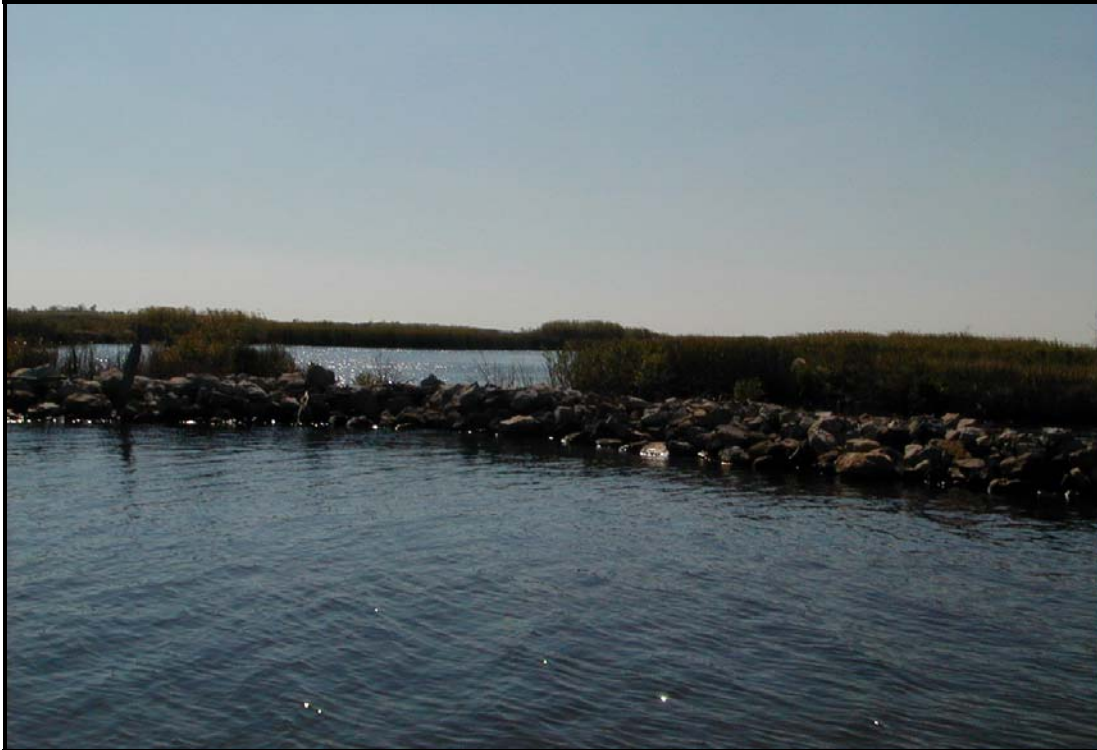
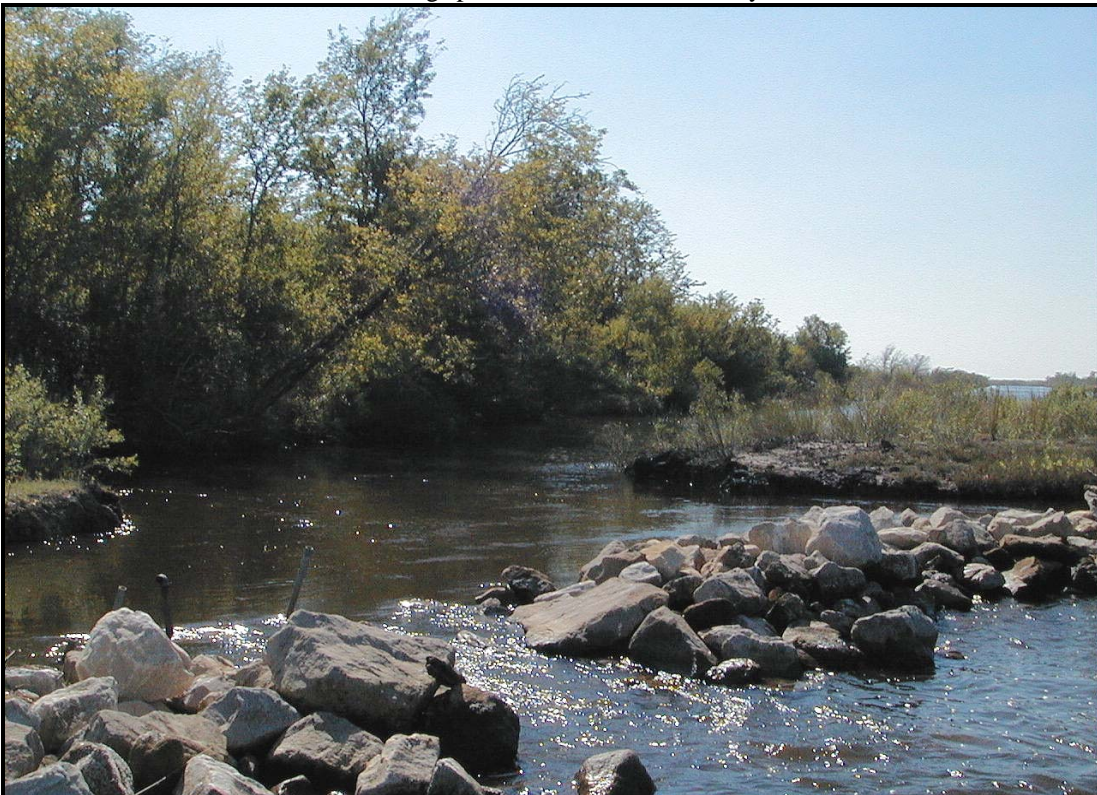
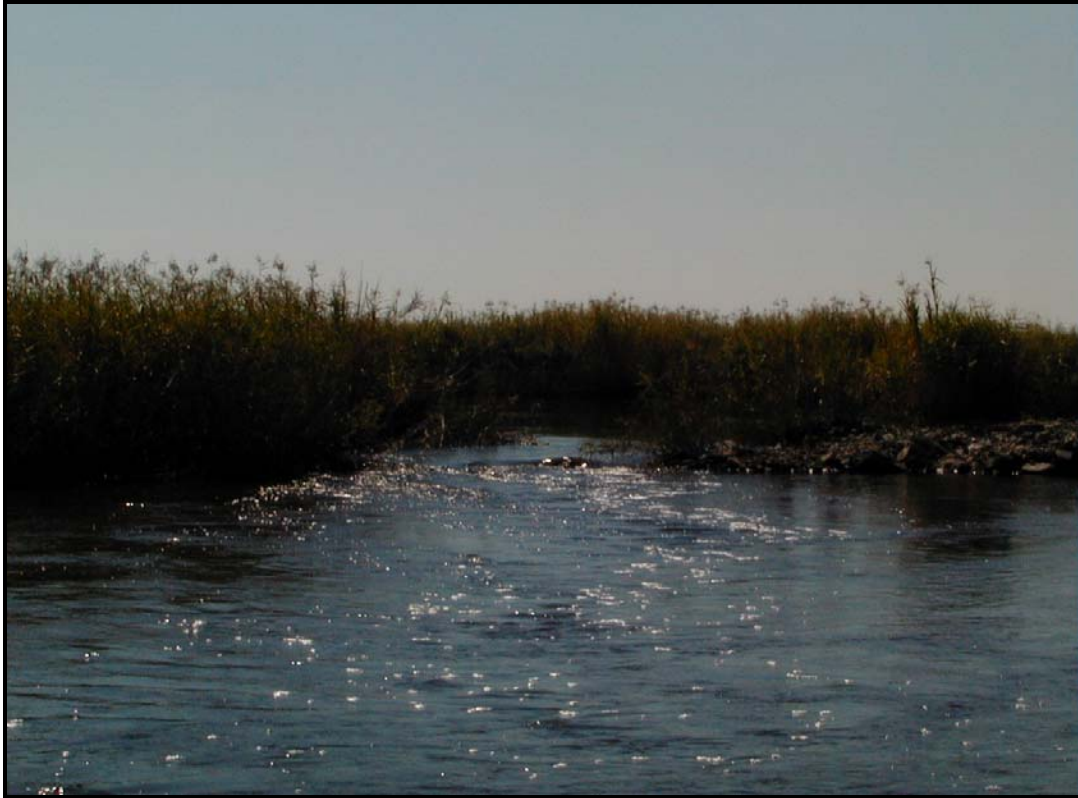
**Photo 15**—Missing spoil on W. end of Black Bayou Closure

**Photo 16**—Missing spoil and gap in rock dike at E. end of Vinton Canal Closure

**Photo 17**—Gap in E. end of C-stone closure at second gap from the east
